# Toxin Analysis of Benthic Cyanobacteria Clumps in Cayuga Lake

Adrianna Hirtler  
Biomonitoring Coordinator, CSI  
adrianna@communityscience.org

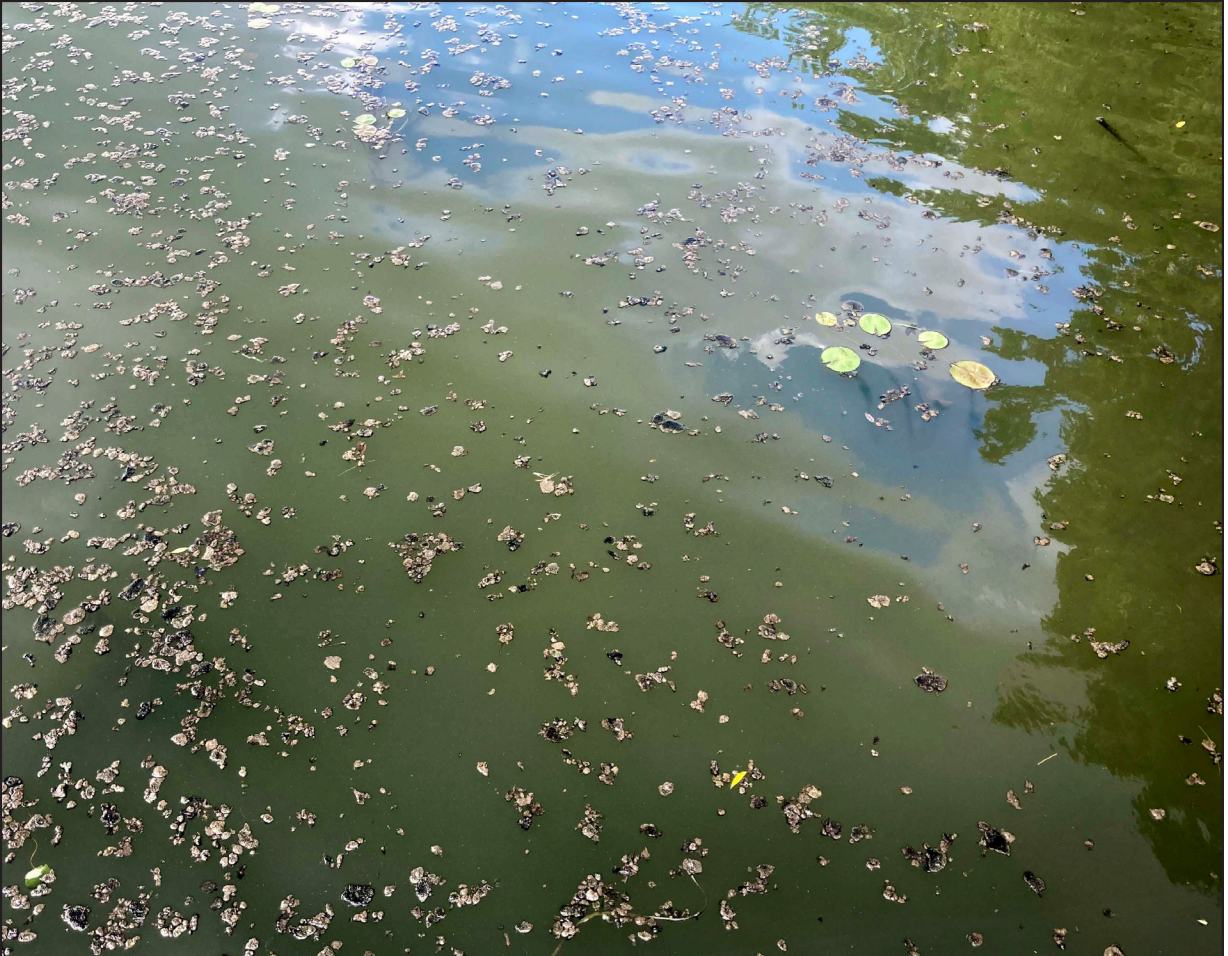
Cayuga Inlet off the dock at the Ithaca Farmer's Market on 6/25/23

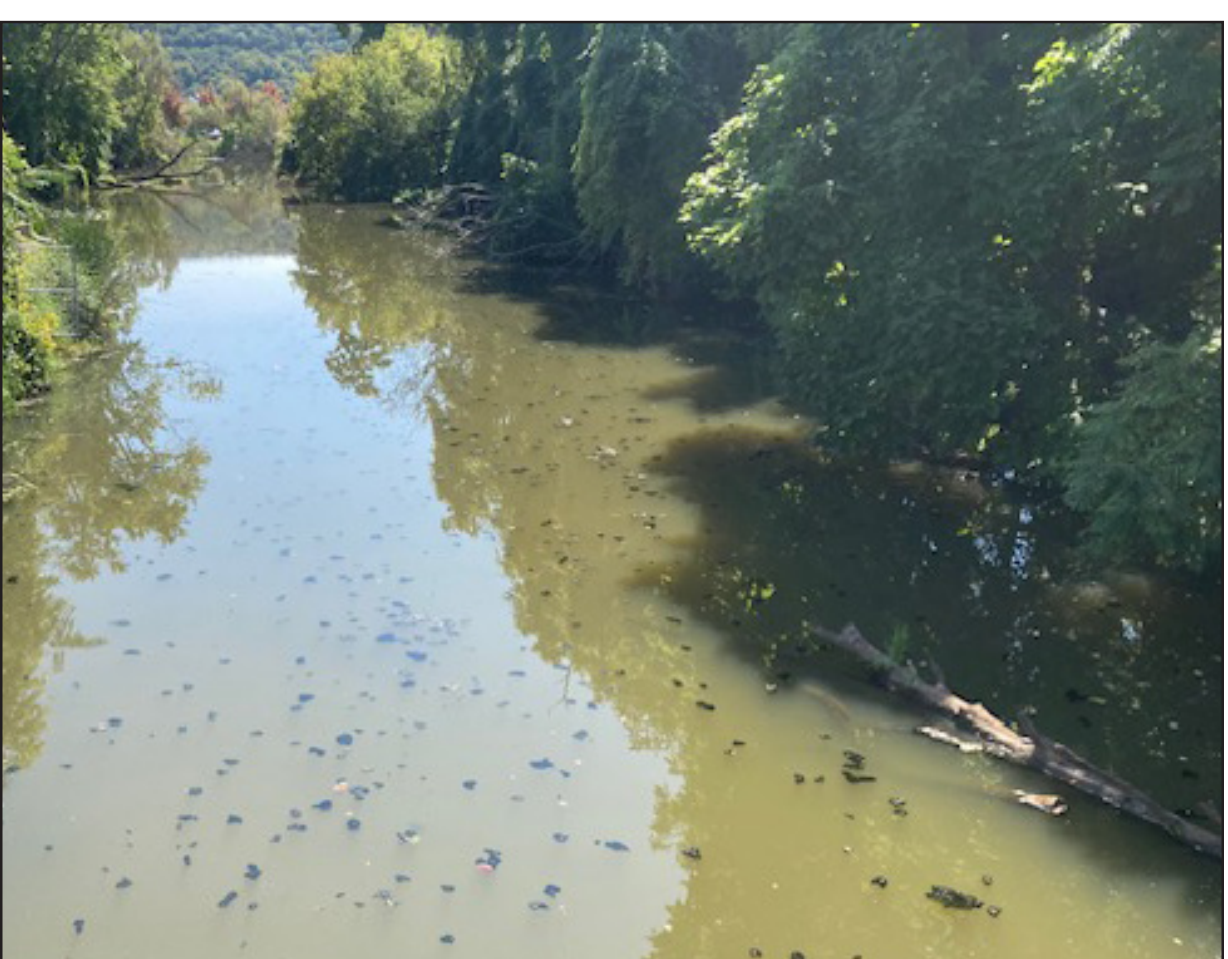
Flood Control Channel between Wegmans and Nate's Floral Estates in the City of Ithaca on 9/5/24

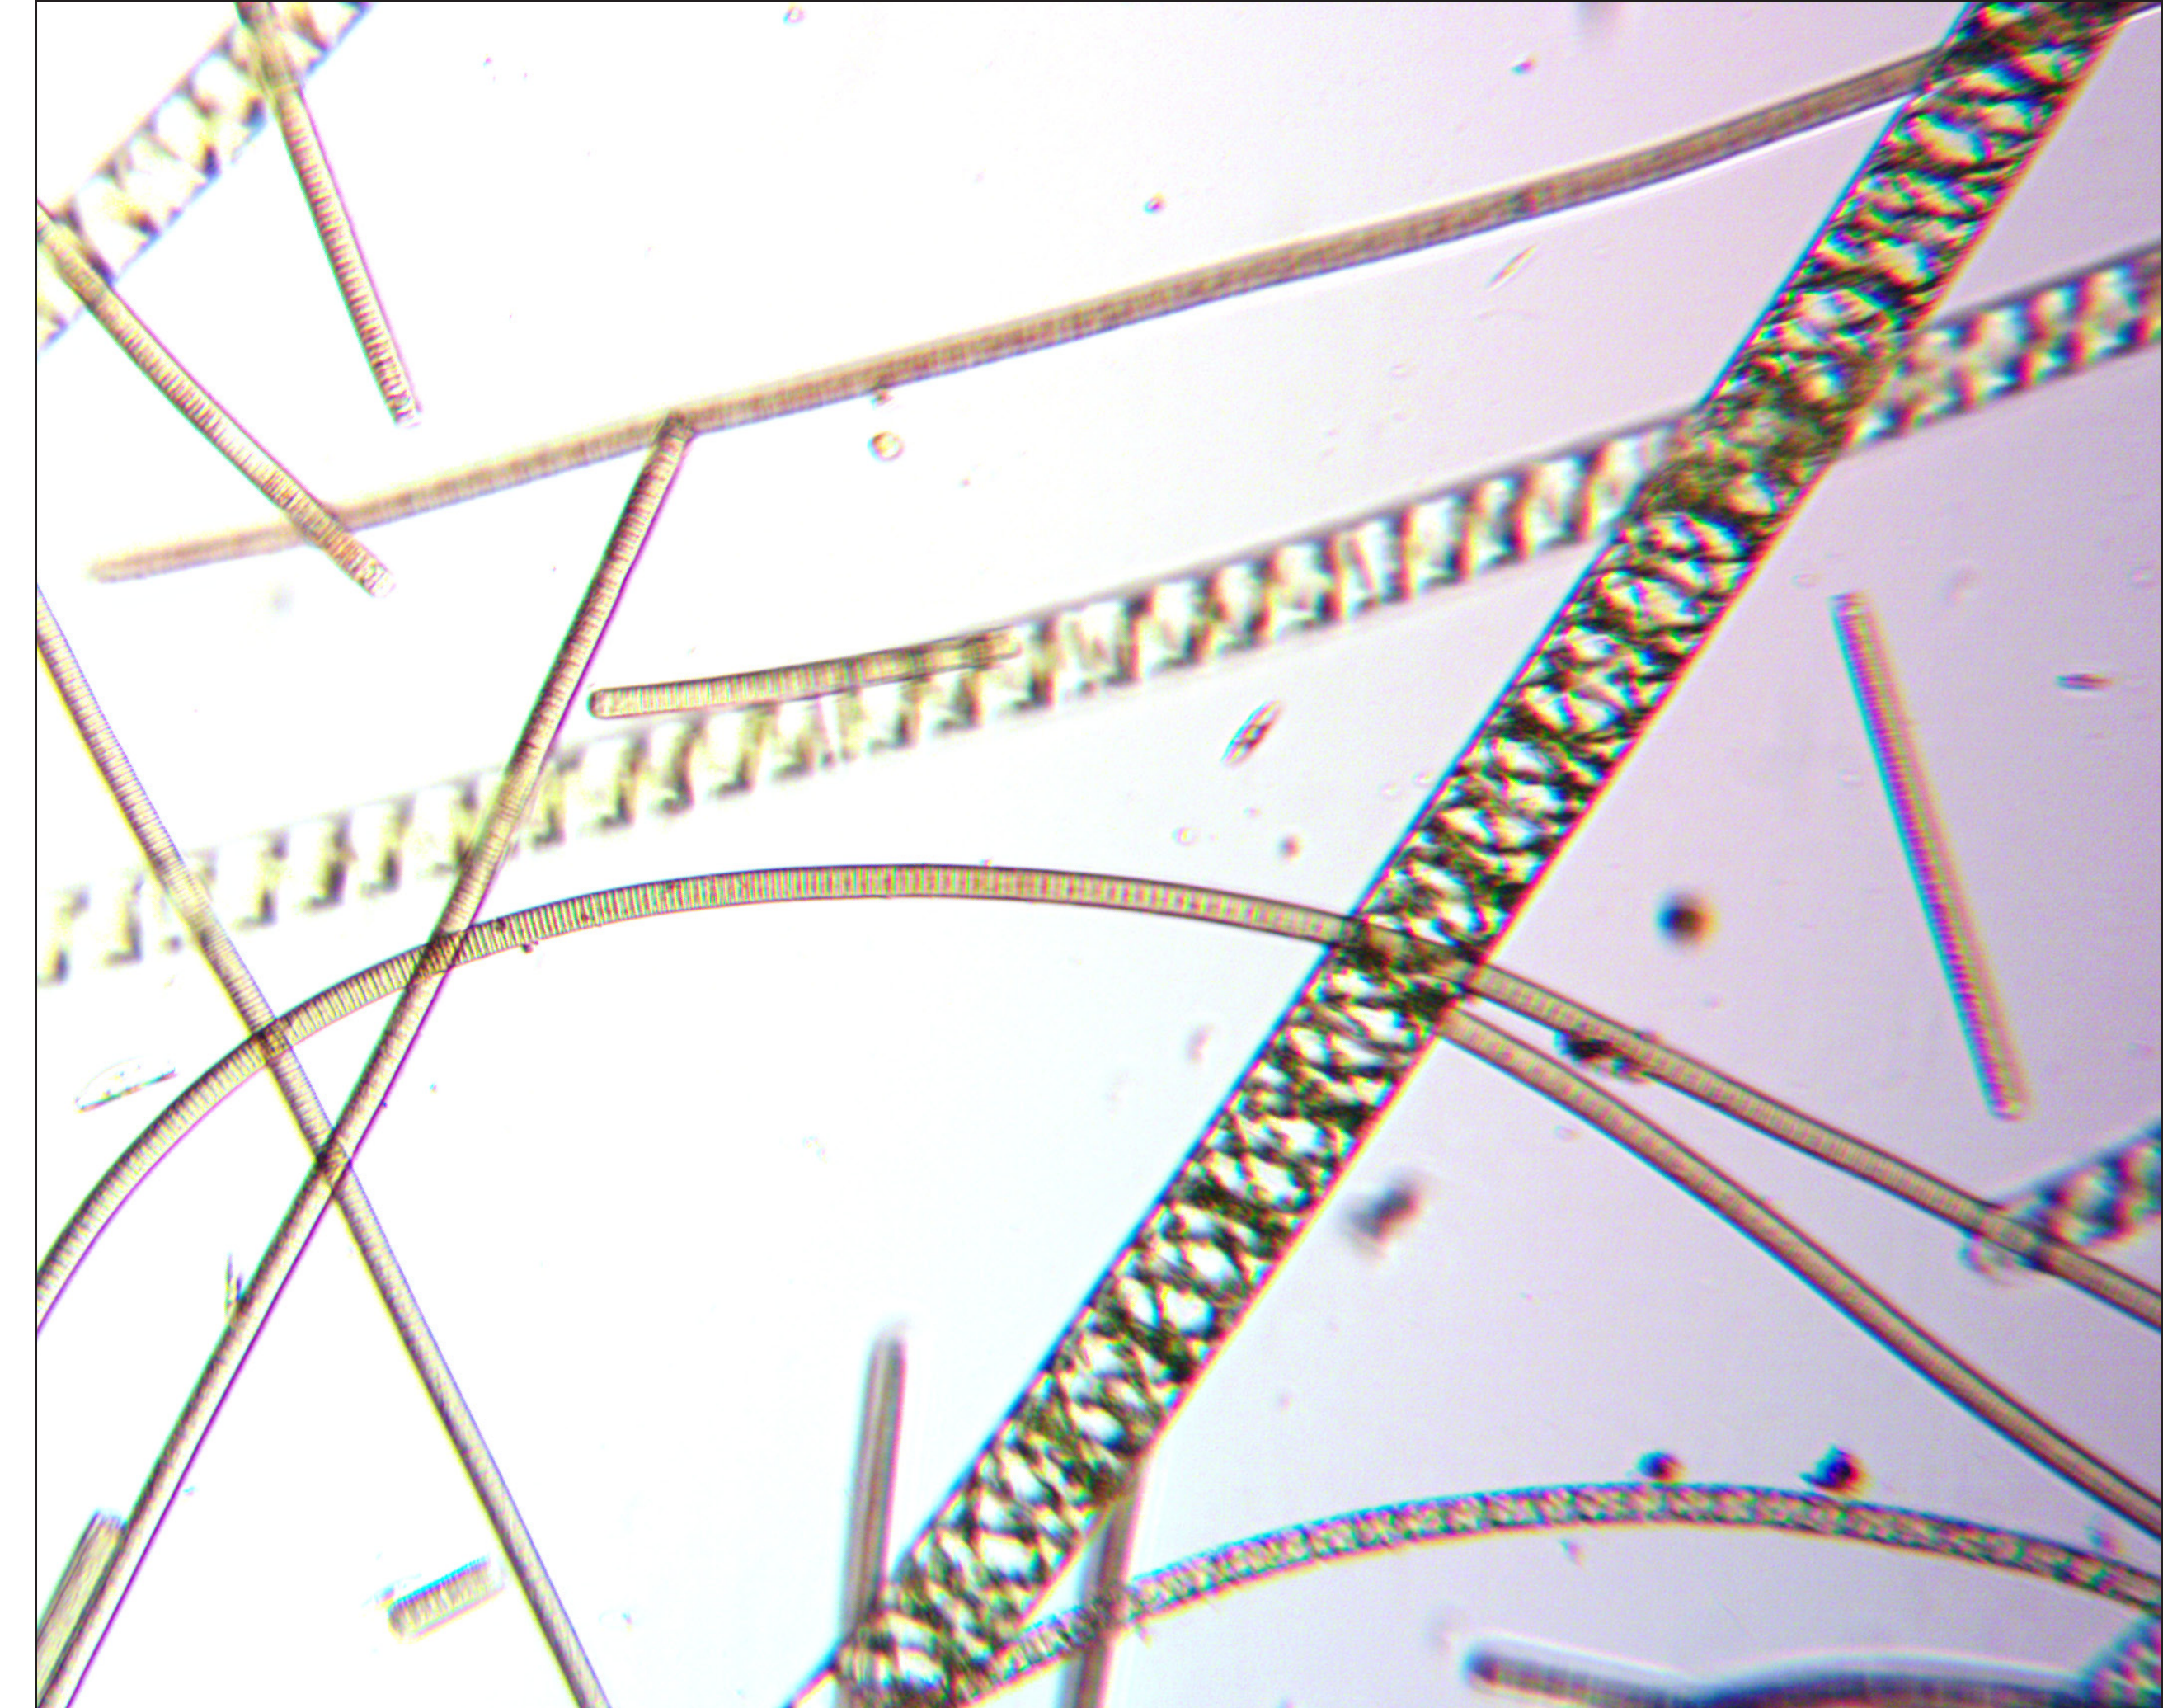
Microscopic view of benthic cyanobacteria clump sample from Cayuga Inlet collected on 6/19/24 showing both the conjugating green algae *Spirogyra* (larger filaments) and cyanobacteria in the Oscillatoriales order (thinner filaments).

Eleven samples of benthic cyanobacteria clumps were collected, mostly in the summer of 2024. It can be seen in the figure at the right that two of the eleven samples were found to contain solidly measurable levels of anatoxins (dominated by homoanatoxin-a, though one of the samples contained small amounts of other anatoxin analogues). Anatoxins are the most common cyanotoxins associated with benthic cyanobacteria (Bauer et al. 2023, Quiblier et al. 2013) and anatoxins are also the most commonly reported cyanotoxins linked to animal deaths (Wood et al. 2020). Anatoxin-a, an alkaloid neurotoxin, is sometimes referred to as "Very Fast Death Factor" referring to the potency of the toxin. Homoanatoxin-a is considered to have identical toxicological properties to anatoxin-a (D'Anglada et al. 2015, WHO 2022). Anatoxins are produced by numerous genera in the order Oscillatoriales including *Oscillatoria*, *Planktothrix*, and *Phormidium*. Microscopy of the eleven HAB clump samples submitted as part of the pilot study indeed showed that cyanobacteria within the order Oscillatoriales were present in all of the submitted samples.

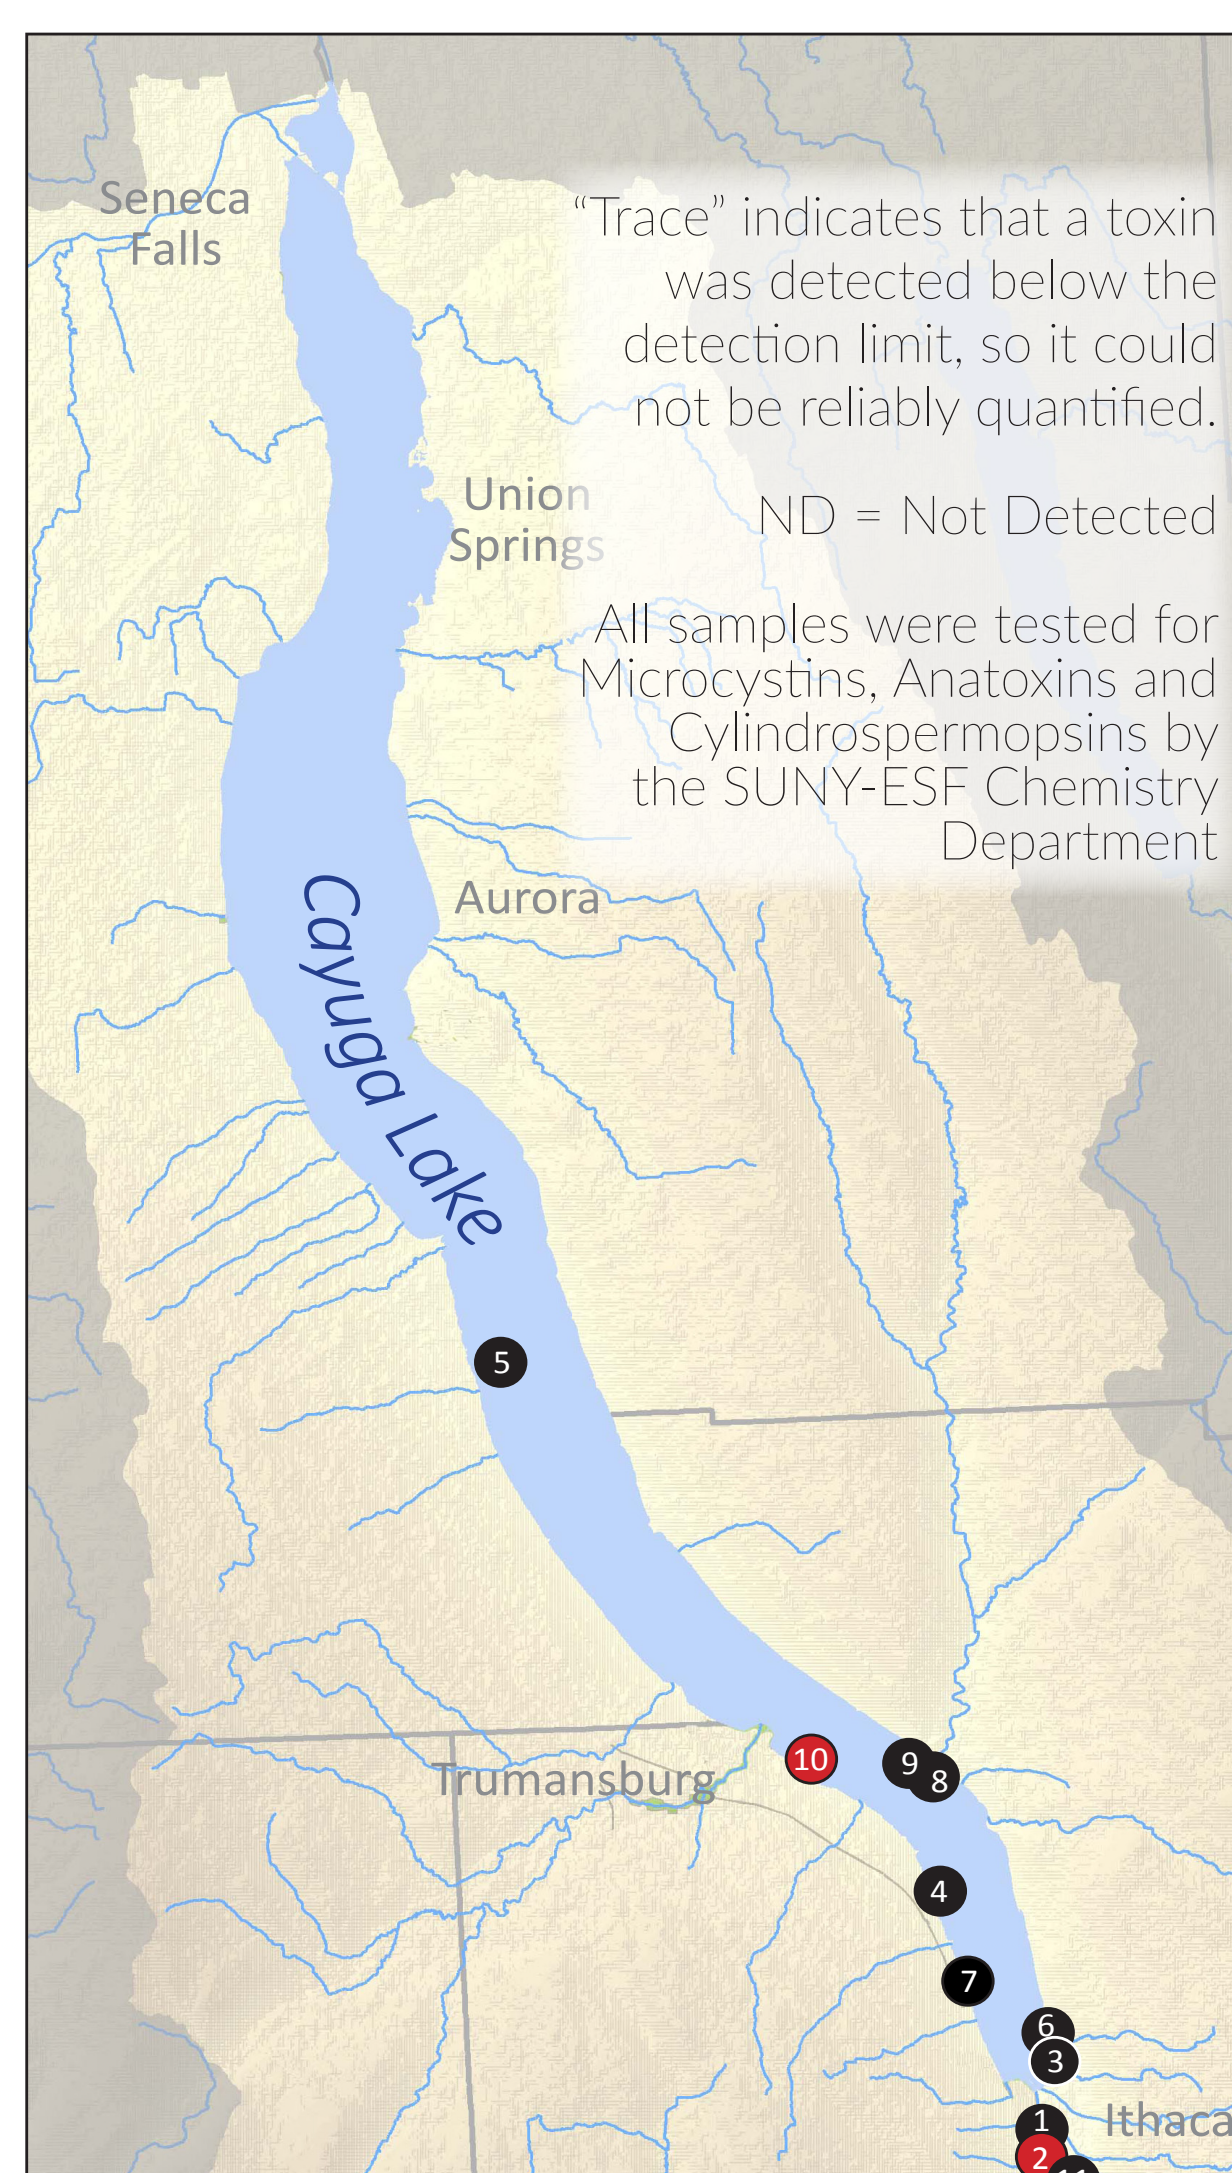
Toxin results	Date	Latitude	Longitude	Location
1	ND	6/26/23	42.451327	-76.509745	Ithaca Farmer's Market dock
2	Anatoxins 3,424 µg/g	6/19/24	42.442883	-76.511762	Cayuga Inlet across from Deep Dive
3	ND	6/19/24	42.471473	-76.503798	East Shore Park
4	Trace Anatoxins <0.044 µg/g	7/12/24	42.49487	-76.53679	Open water near outfall of Glenwood Creek
5	ND	7/12/24	42.633056	-76.686944	Open water north of Lively Run Creek
6	ND	7/14/24	42.472490	-76.504185	East Shore Park
7	ND	7/15/24	42.482194	-76.533695	Private west shore beach
8	ND	8/7/24	42.538568	-76.549924	Near Myer's Point swimming area
9	ND	8/13/24	42.3219	-76.330	South side of Salt Point
10	Anatoxins 1,349 µg/g	8/27/24	42.53749	-76.58387	Open water south of Taughannock
11	ND	9/5/24	42.436366	-76.512617	Flood Control Channel near Wegmans

Map shows locations where benthic cyanobacteria clump samples were collected in the southern half of Cayuga Lake. Samples are referenced by numbers on the map and in the table at the right. The samples in which toxins were detected are highlighted in red.
