2024 Cayuga Lake Harmful Algal Bloom Season in Review: Earliest, Latest, and Most Blooms Ever

*Cayuga Lake Harmful Algal Bloom Monitoring Program Coordinator,
Outreach and Programs Coordinator
Community Science Institute*

Cayuga Lake Watershed Network
Spring 2025 Community Conference in Canoga
Canoga Volunteer Fire Department, June 25, 2025

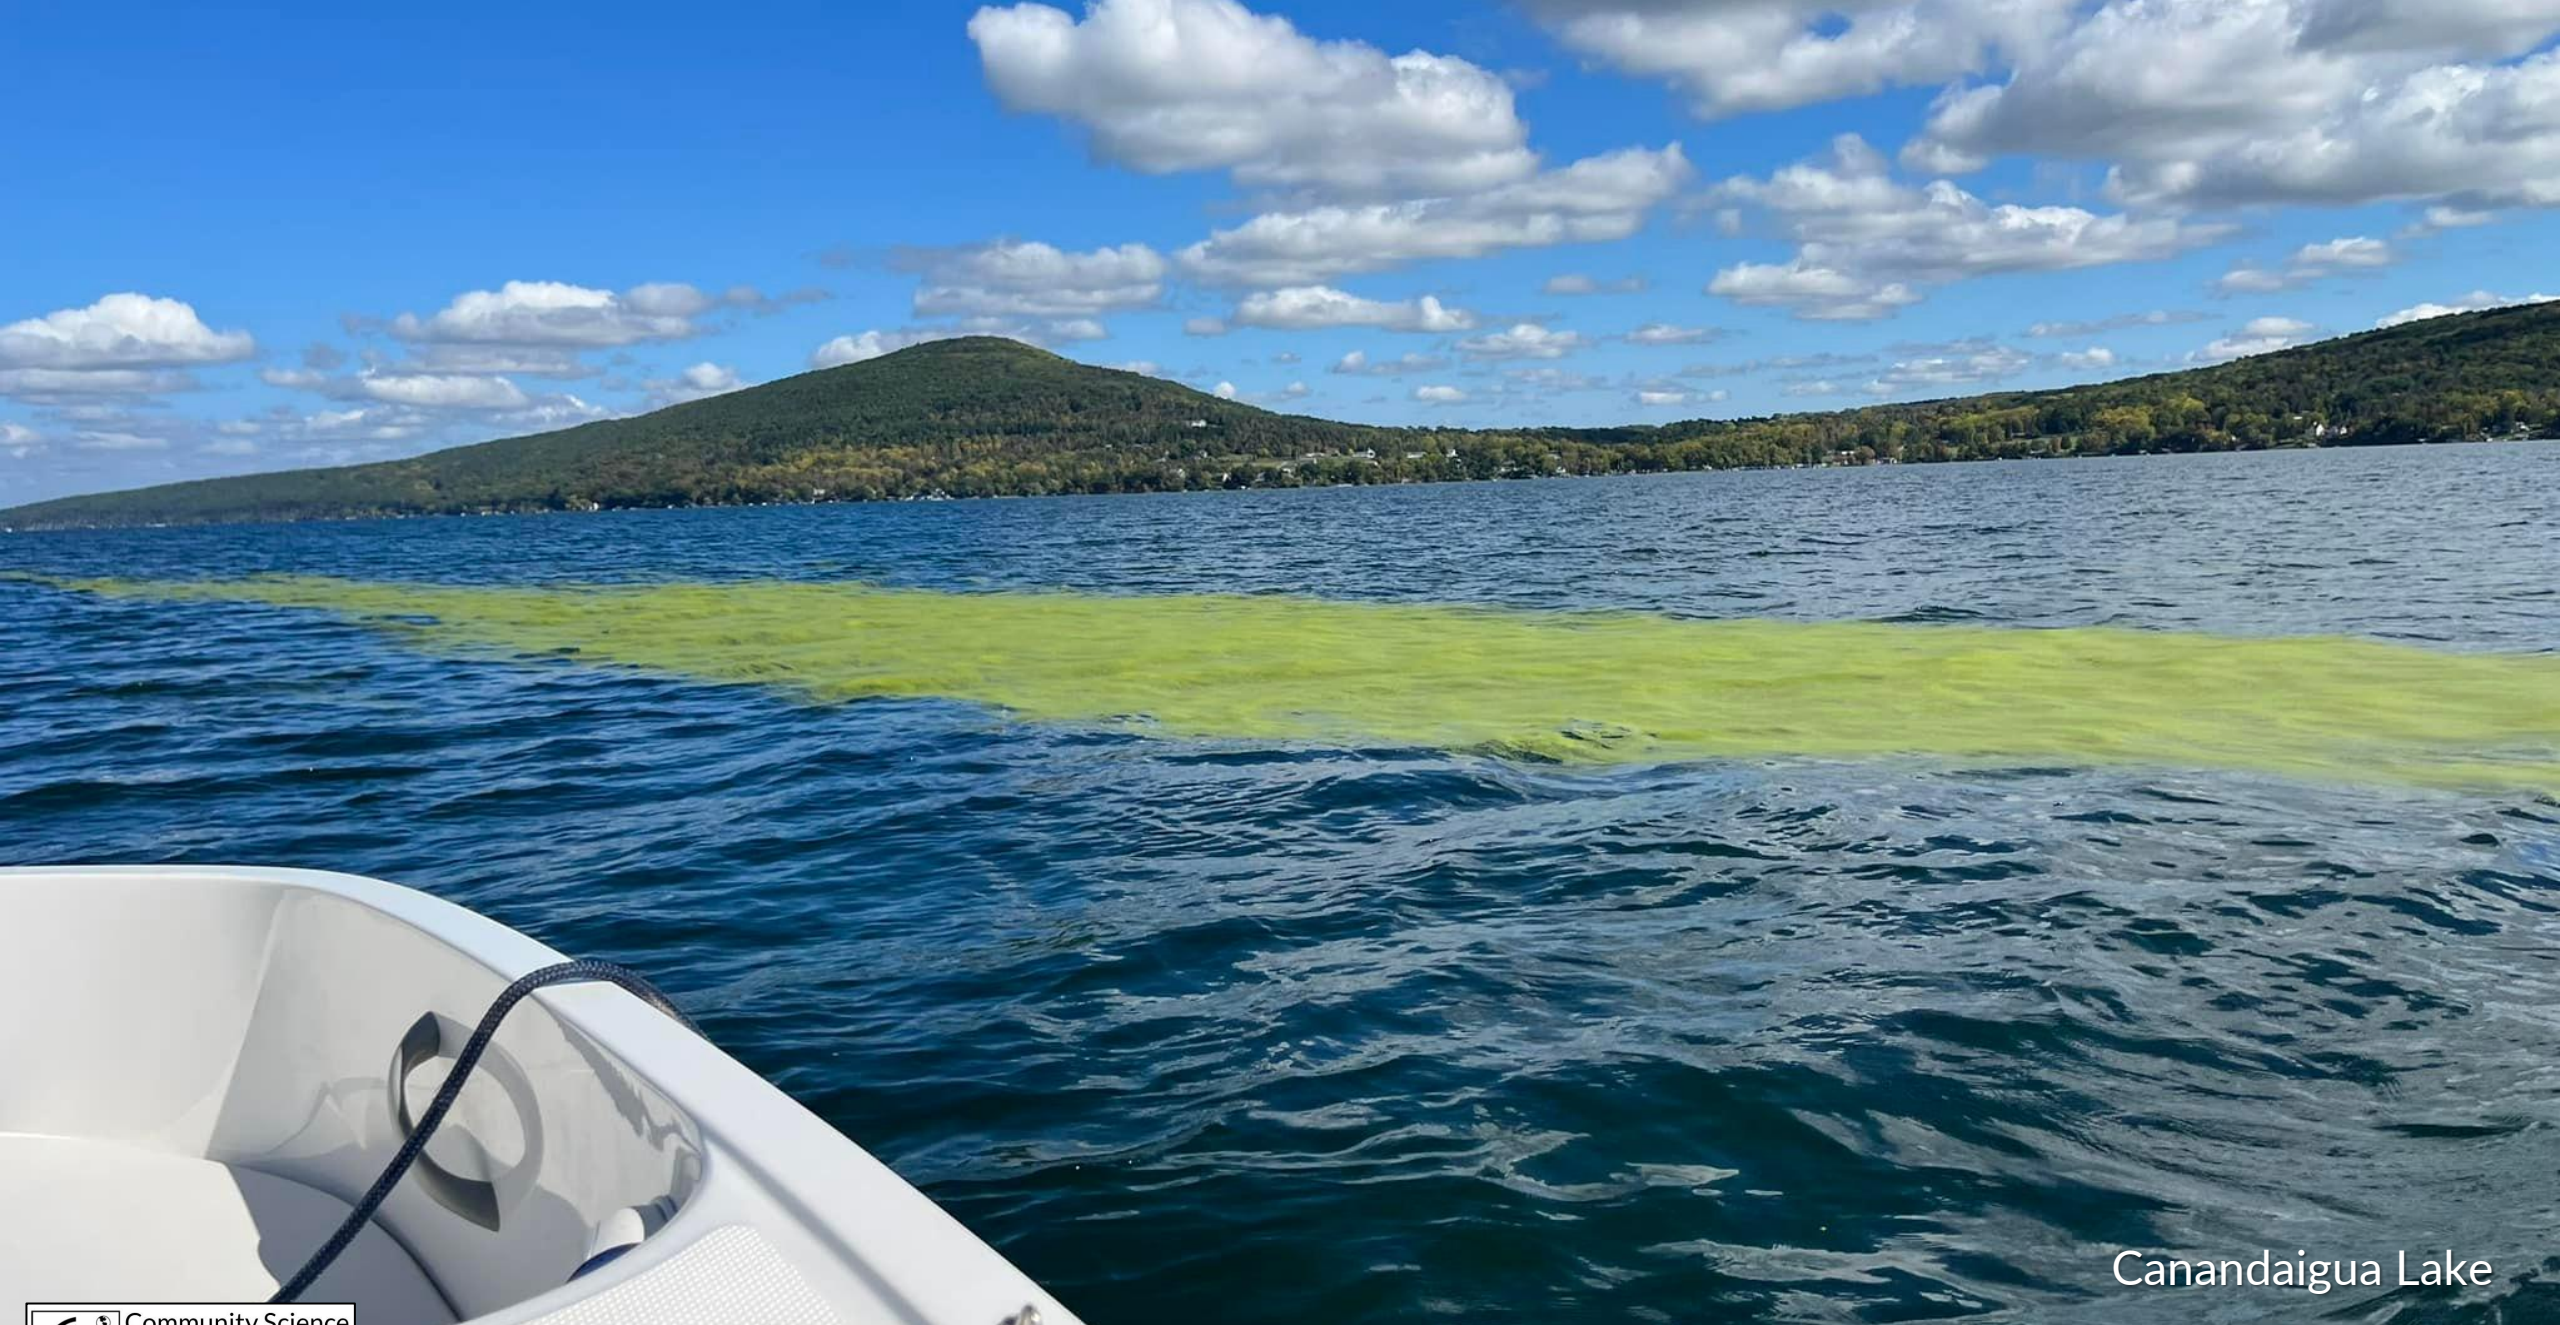
HABs Identification: Clumps

Physical characteristics:

- Floating clumps found floating on the surface of the water
- Dislodged from the lake bottom (benthic)
- Often confused with goose poop

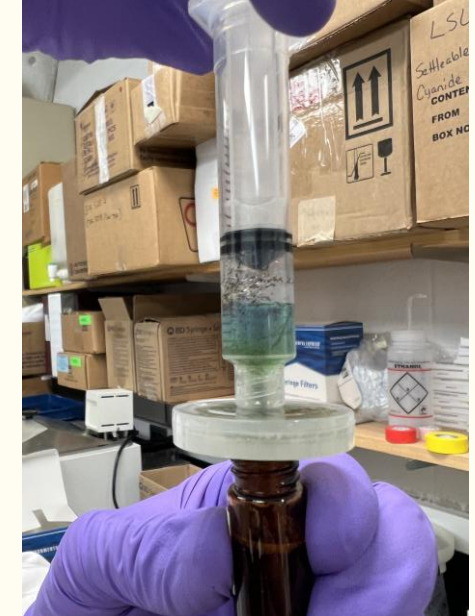
HAB samples are analyzed to:

- Identify cyanobacteria genera
- Measure chlorophyll a (EPA 446.0 Rev. 1.2)
- Measure microcystin (EPA 546)

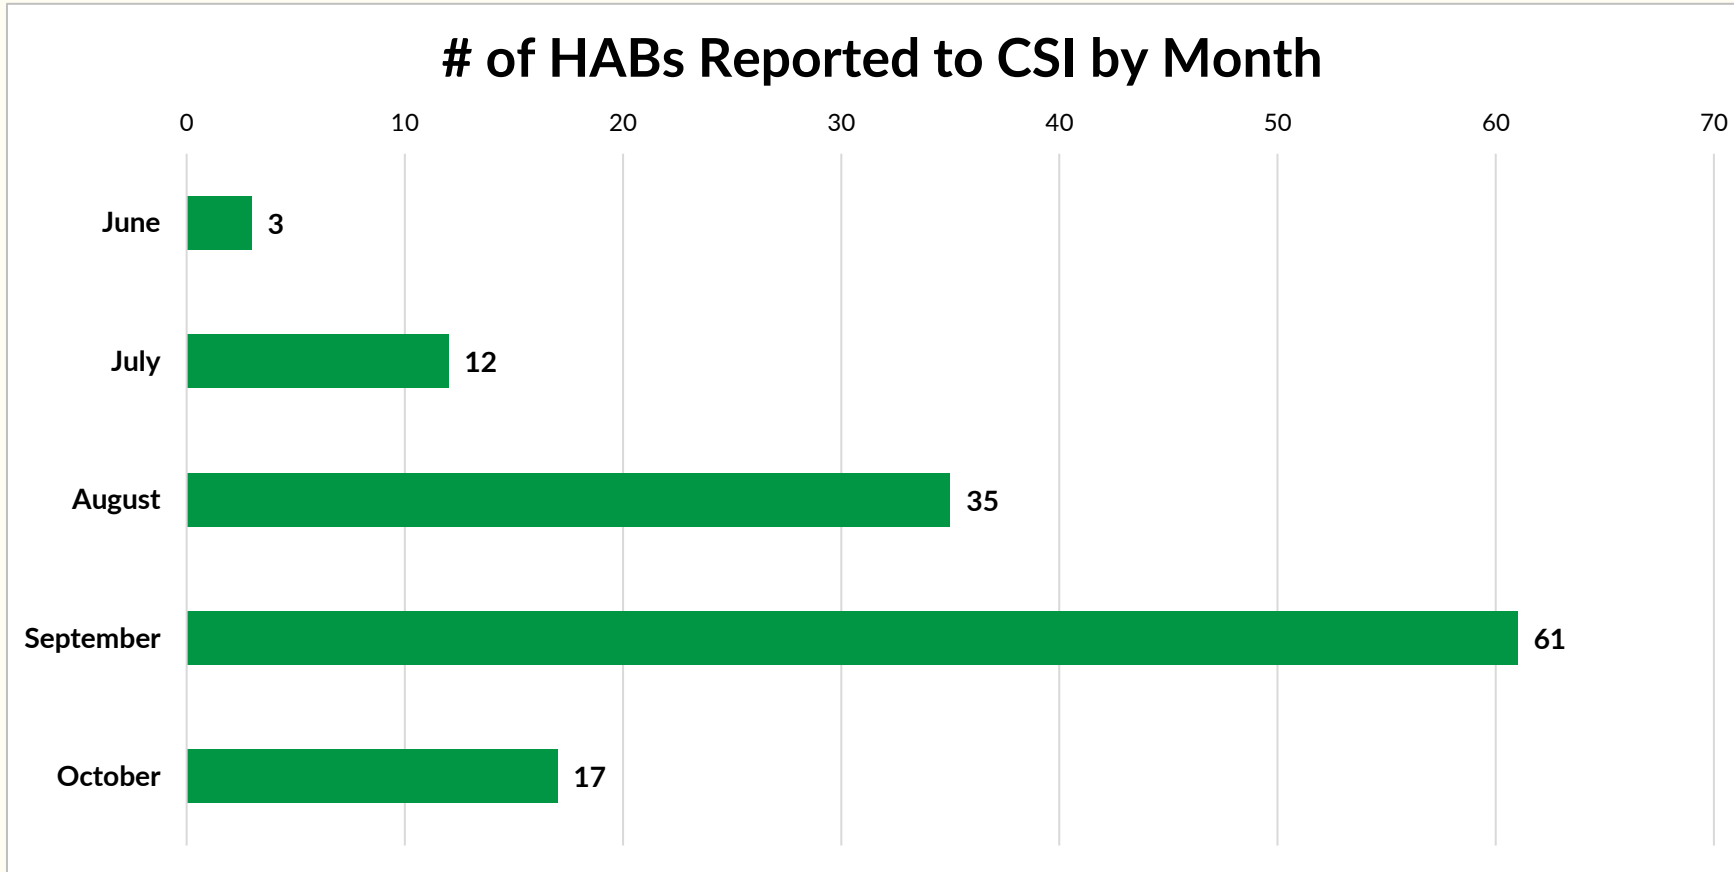
127 total!

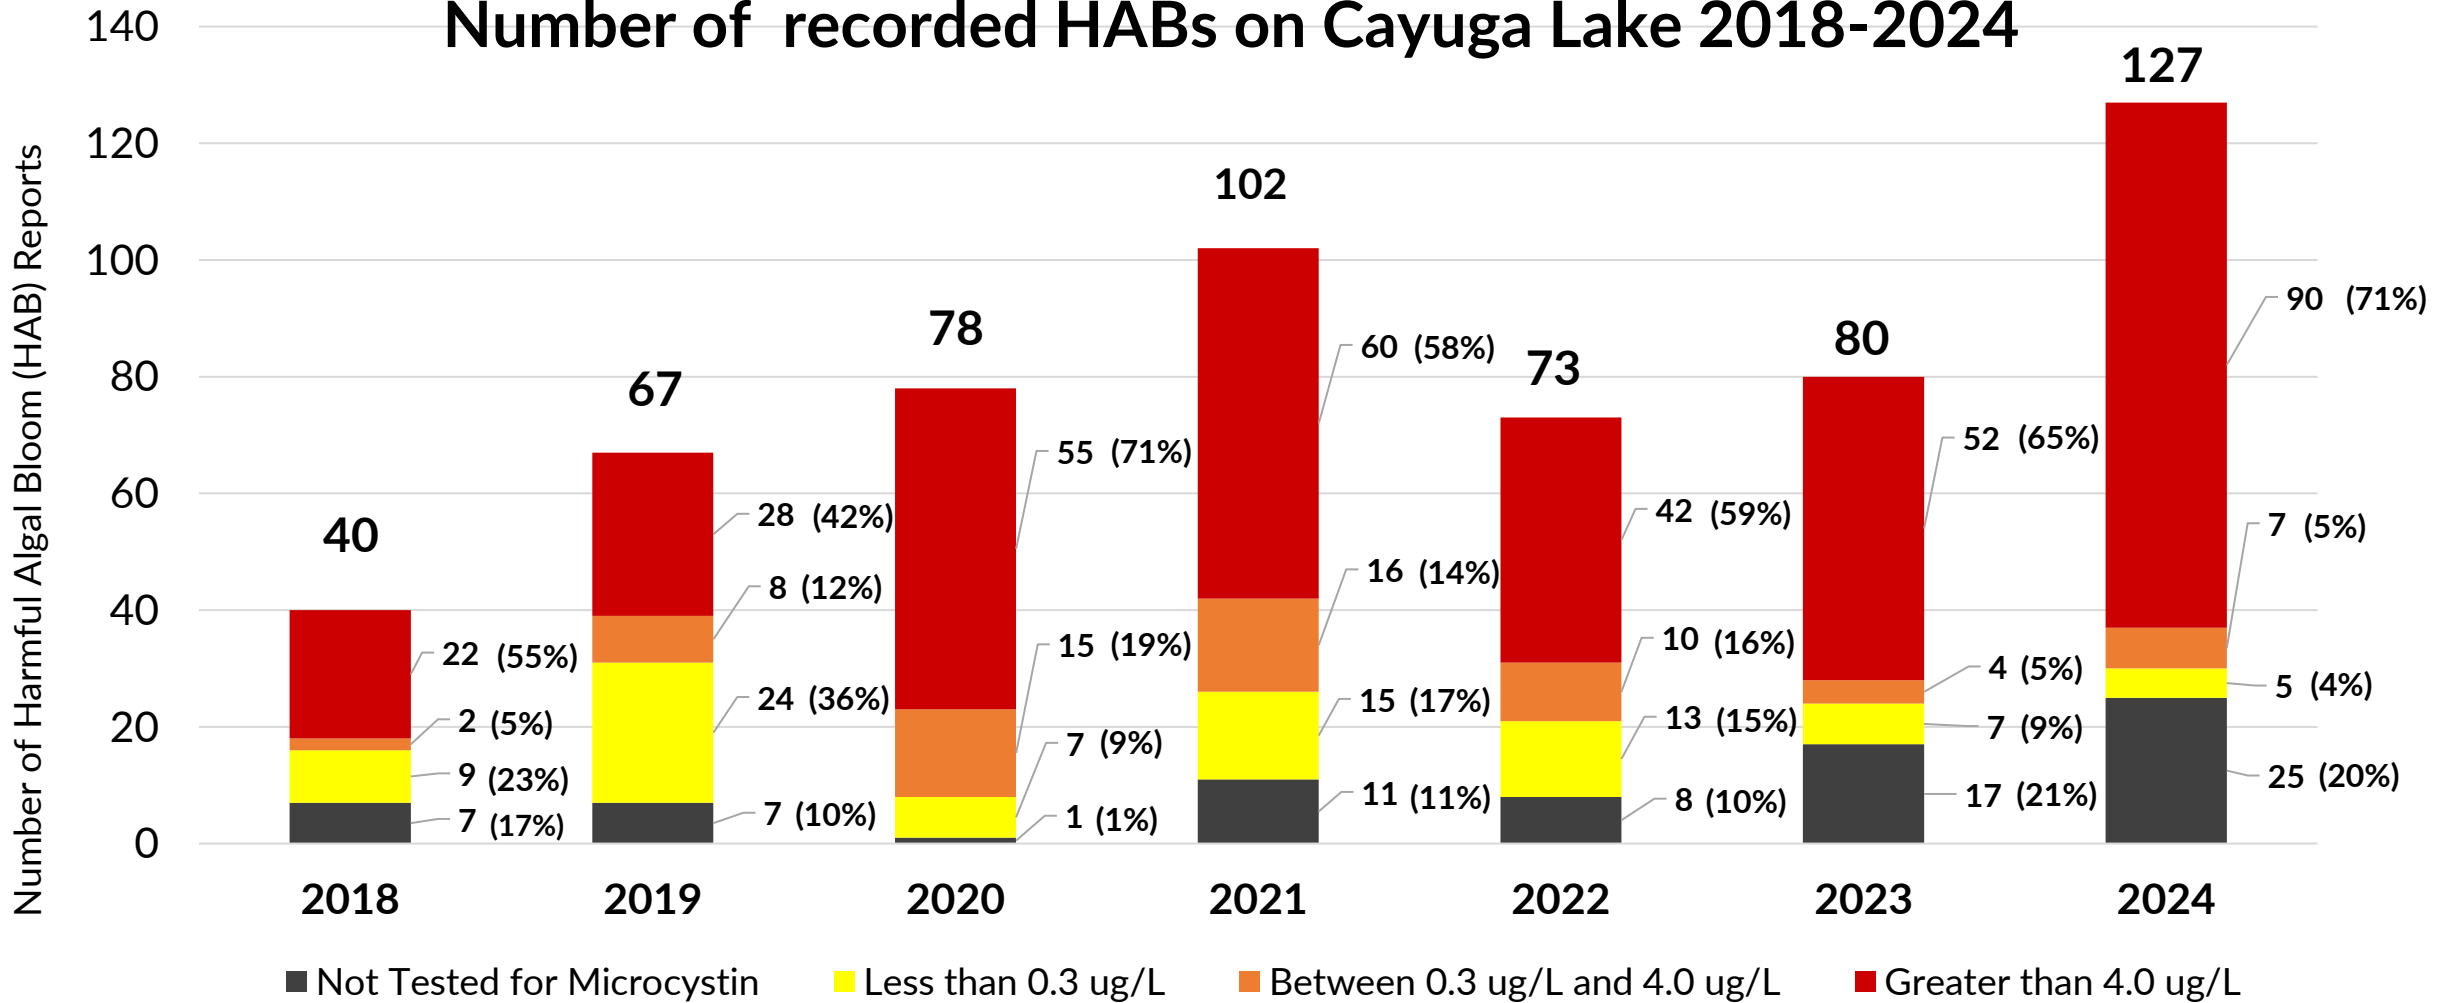
Number of recorded HABs on Cayuga Lake 2018-2024

The most **HABs** reported in a single year:

- From June – July, Cayuga Lake HABs tend to be dominated by *Dolichospermum* sp.. From August to October, blooms tend to be dominated by *Microcystis* sp.
- Blooms that are *Microcystis*-dominant usually have higher levels of microcystin toxin than blooms that are **not** *Microcystis*-dominant
- There is a strong positive relationship between chlorophyll a and microcystin concentration in HABs that are *Microcystis*-dominant.
- Since 2020, more than half of the HAB samples collected each year have microcystin concentrations greater than the contact recreation limit (4 ug/L)
- The number of HAB reports increased from 2018-2021, then plateaued in 2022-2023, and took off again in 2024
- What will 2025 bring? So far, so good!

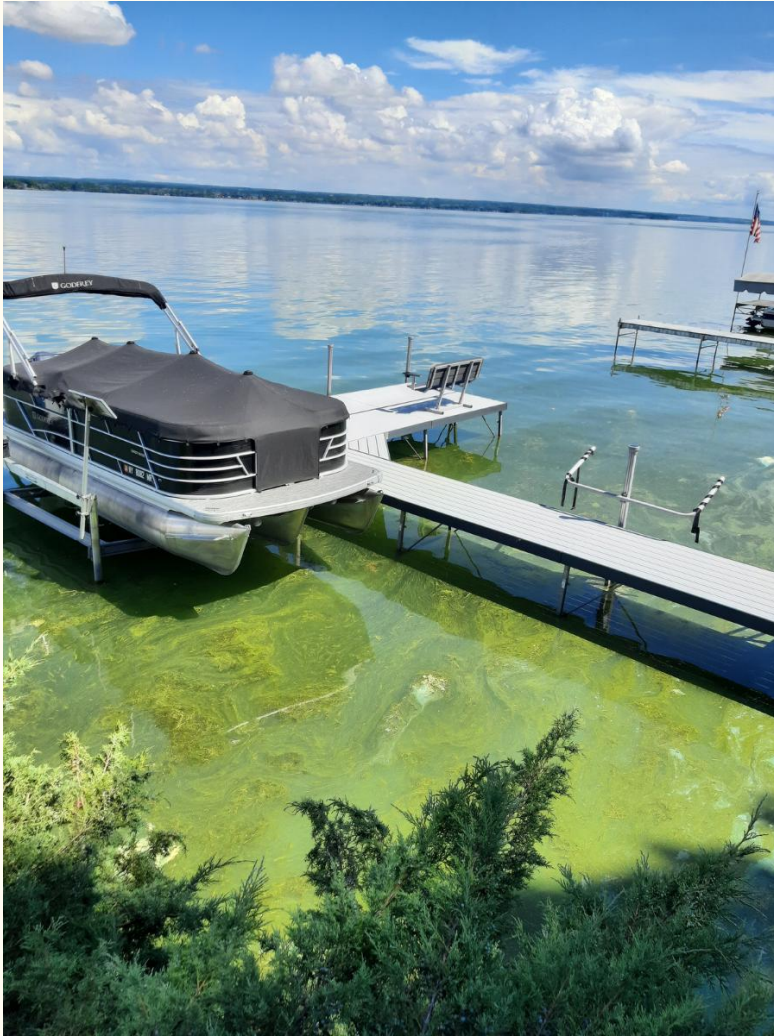
The earliest **HAB** reported on CSI's record:

- June 3rd, 2024
- 1 reported by homeowner on Lower Lake Road, Town of Seneca Falls
- Anecdotal reports the bloom stretching for close to 2 miles along the western shore

Cayuga Lake had its first confirmed Harmful Algal Bloom (HAB) of 2024 on Monday, June 3rd. It was spotted by a vigilant homeowner on Lower Lake Rd in the town of Seneca Falls who promptly reported the bloom. Many thanks to the homeowner for taking excellent photos and including all the relevant information using the bloom reporting form so that all the necessary information could be documented and reviewed by our partners at the Community Science Institute (CSI). Since then, there have been additional reports of blooms in the area. The Cayuga Lake State Park Beach is closed and signs have been posted.

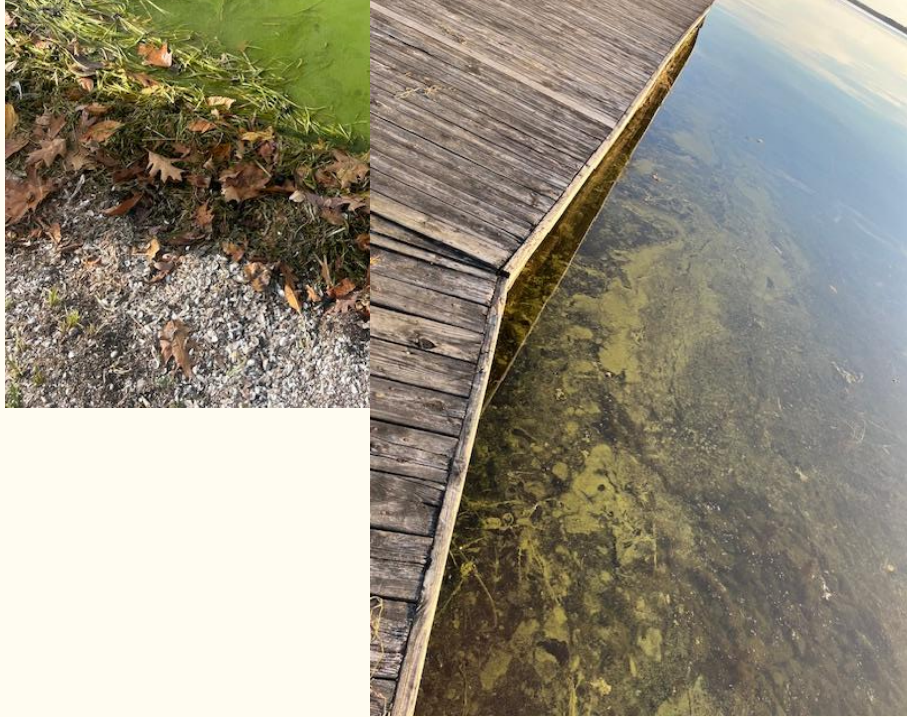
The latest **HABs** reported on CSI's record:

- October 28th, 2025
- 2 reported by HABs Harriers
- Harris Park in Cayuga
- Farley's Point in Union Springs

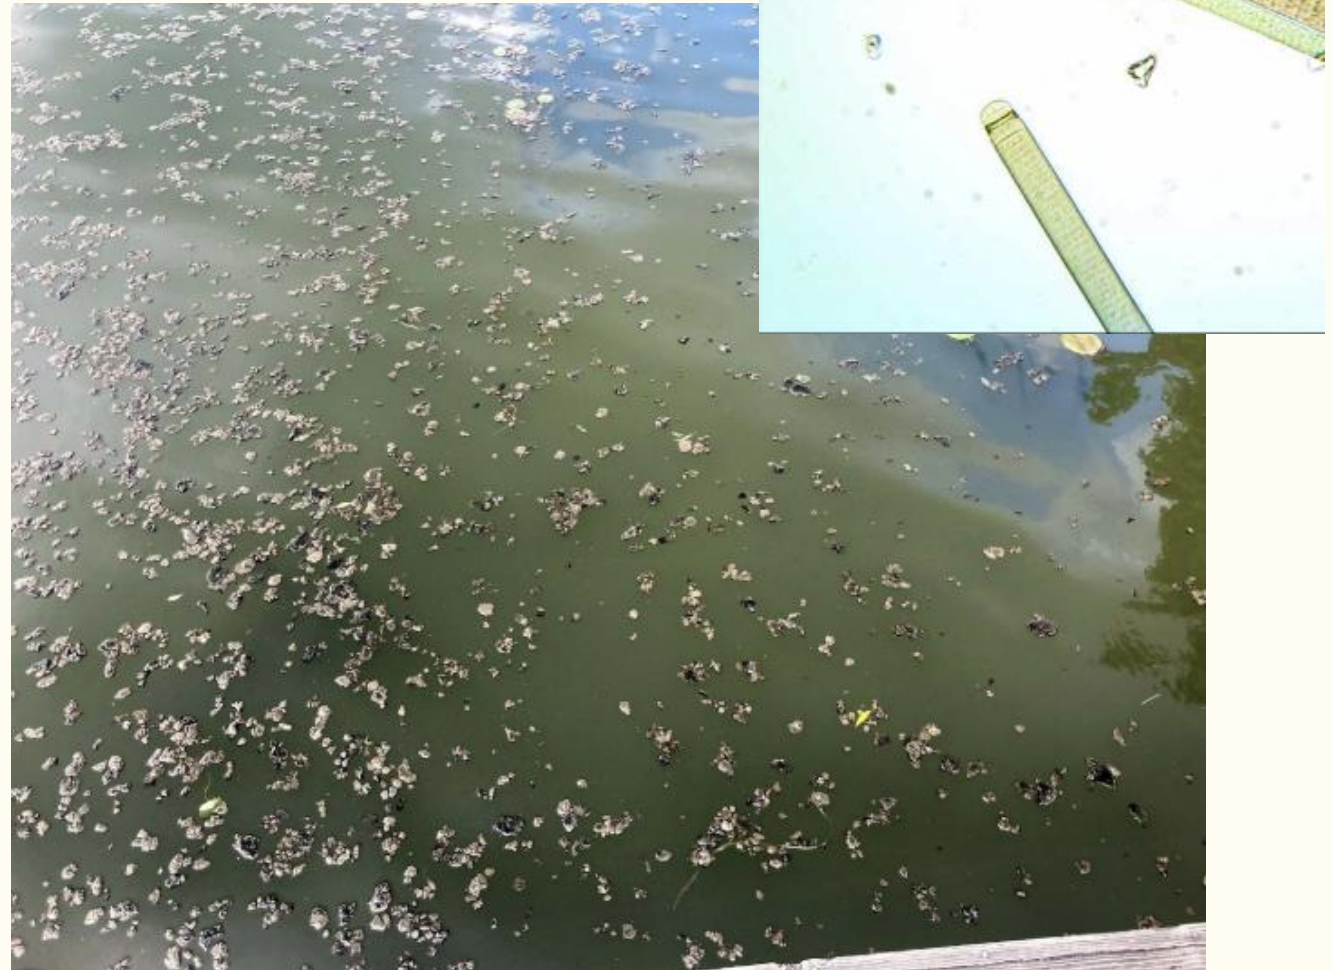
2024 Toxin Analysis of Benthic Cyanobacteria Clumps in Cayuga Lake

2024 Pilot Study: HAB Clumps

- Found in Cayuga Inlet and Southern end of Cayuga Lake in 2022 and 2023
- The appearance of these clumps contradicts traditional HAB ID guidance
- One sample was collected in 2023 and tested for a suite of toxins by Greg Boyer's lab at SUNY ESF. No toxins were detected.
- In 2024, CSI invited volunteers to help report and sample these clumps
- Continuing in 2025

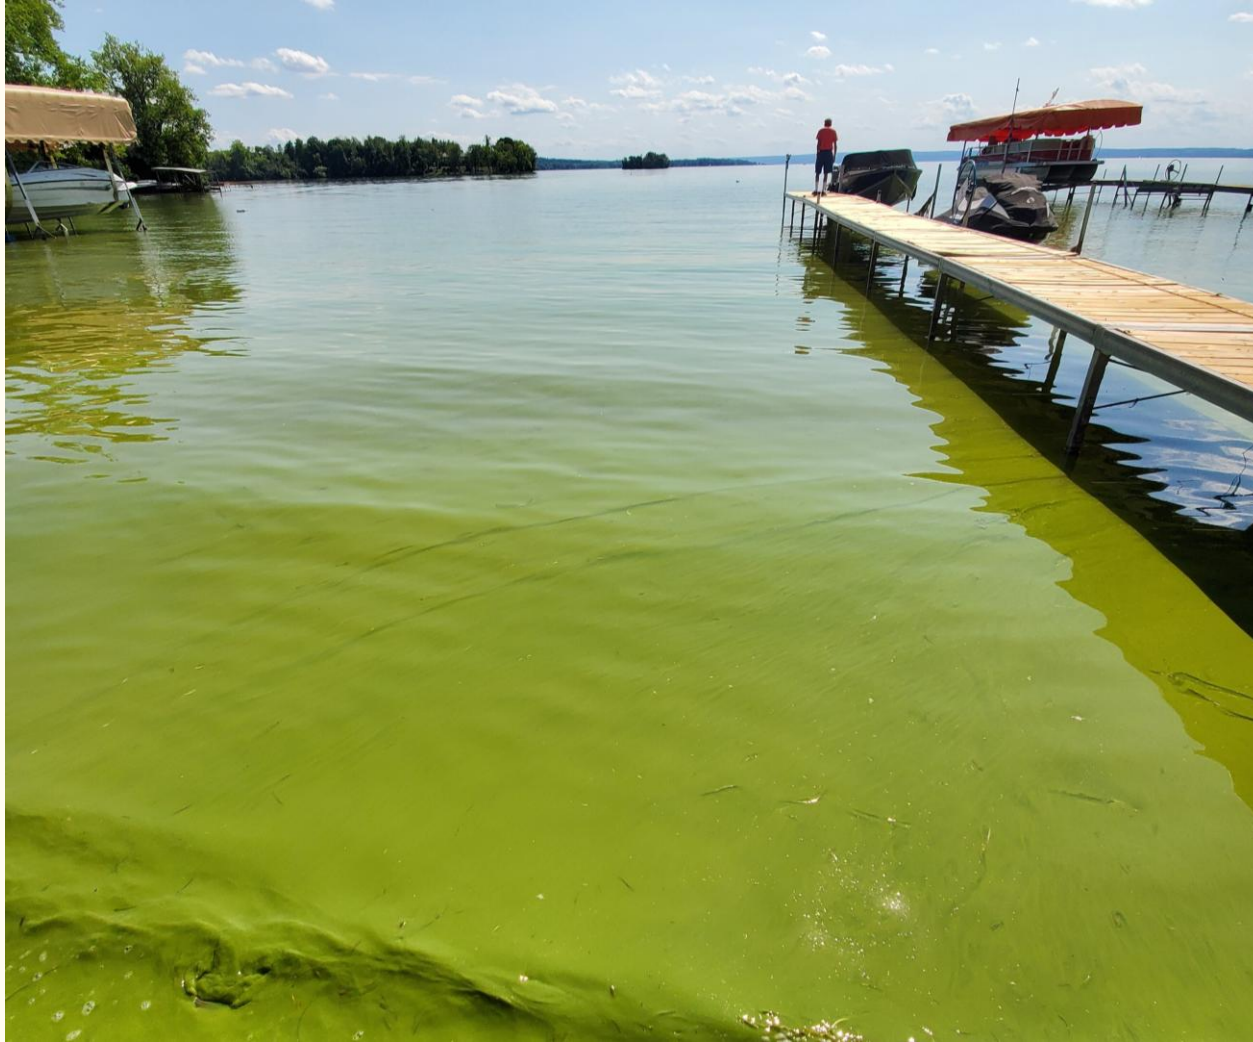
HAB ✓
